## National Transportation Safety Board Aviation Accident Preliminary Report

<b>Location:</b>	Ketchikan, AK	<b>Accident Number:</b>	CEN19MA141B
<b>Date &amp; Time:</b>	05/13/2019, 1221 AKD	<b>Registration:</b>	N959PA
<b>Aircraft:</b>	De Havilland DHC-3	<b>Injuries:</b>	1 Fatal, 9 Serious, 1 Minor
<b>Flight Conducted Under:</b>	Part 135: Air Taxi & Commuter - Non-scheduled - Sightseeing

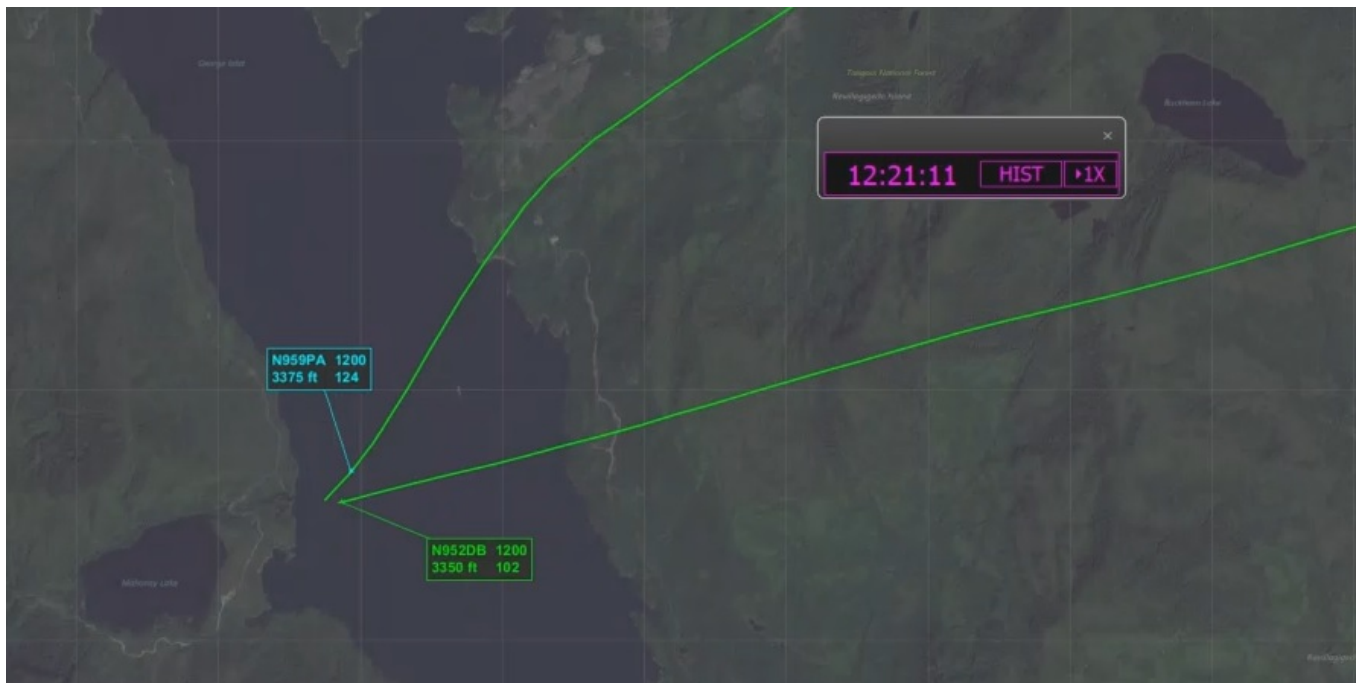
Figure 1. Flight Track

Preliminary flight track data revealed the DHC-3 was traveling southwest about 3,700 ft mean sea level (msl) and gradually descending at 126 knots (kts) when it crossed the east side of the George Inlet. The DHC-2 was traveling west/southwest about 3,350 ft msl at 107 kts when it crossed the east side of the George Inlet. The airplanes collided about 3,350 ft msl near the west side of the George Inlet, east of Mahoney Lake, and data signals were lost. See Figure 1. Flight Track.
